**MARYLAND HISTORICAL TRUST  
DETERMINATION OF ELIGIBILITY FORM**

Property Name: Worman Log House Inventory Number: F-3-247  
Address: Worman's Mill Road City: Frederick Zip Code: 21701  
County: Frederick USGS Topographic Map: Frederick  
Owner: Market Square at Frederick, LLC Is the property being evaluated a district? ☐ yes  
Tax Parcel Number: 423 Tax Map Number: 1168 Tax Account ID Number: 02-185873  
Project: Market Square Development Agency: \_\_\_\_\_  
Site visit by MHT Staff: ☒ no ☐ yes Name: \_\_\_\_\_ Date: \_\_\_\_\_  
Is the property located within a historic district? ☒ yes ☐ no

**Building Description**

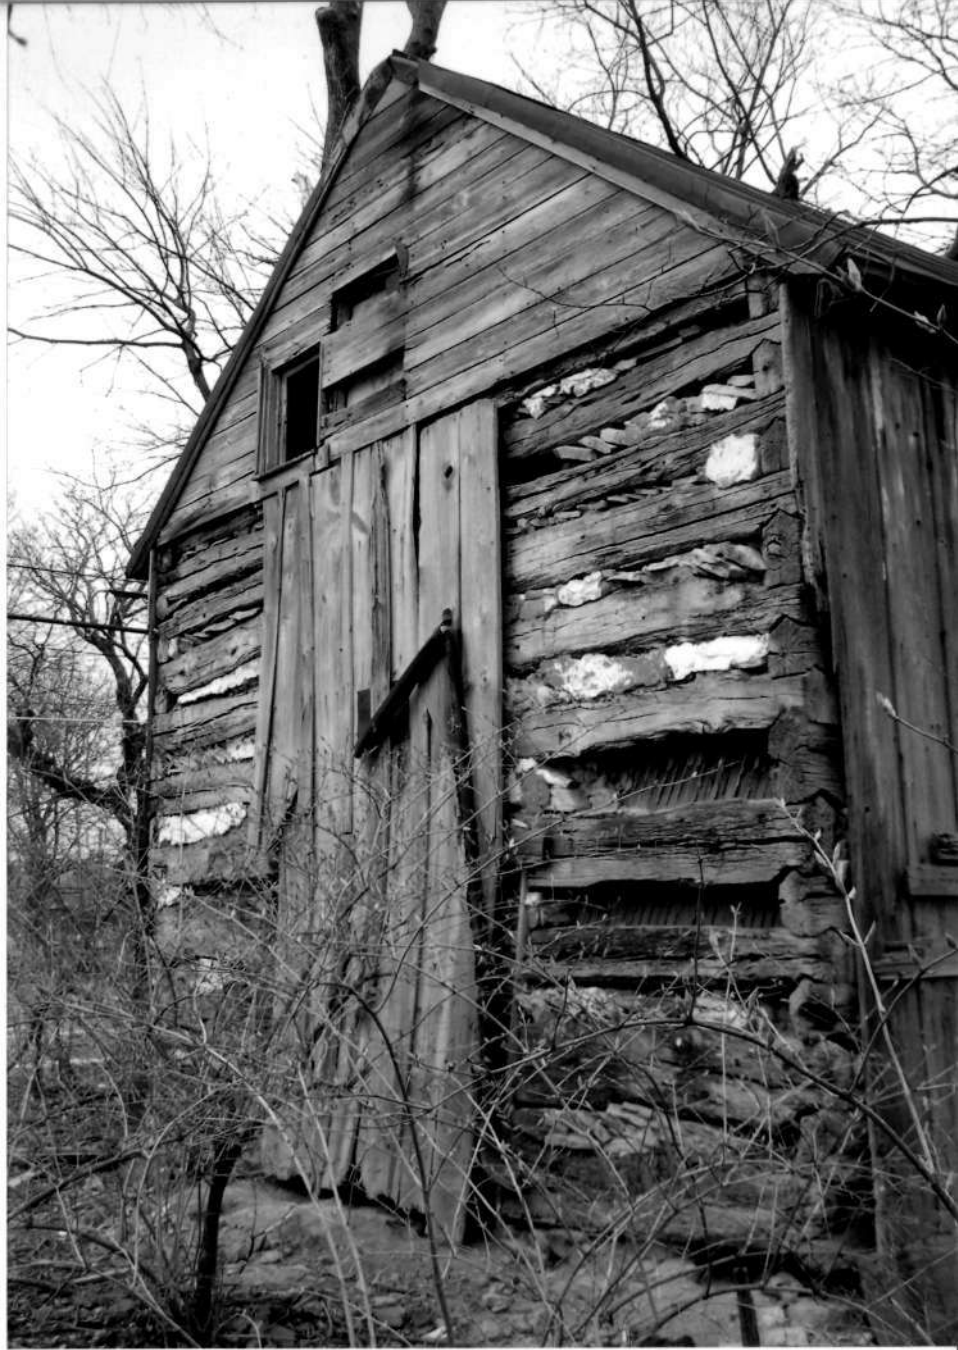
Log House, South elevation, facing northwest  
1 of 11

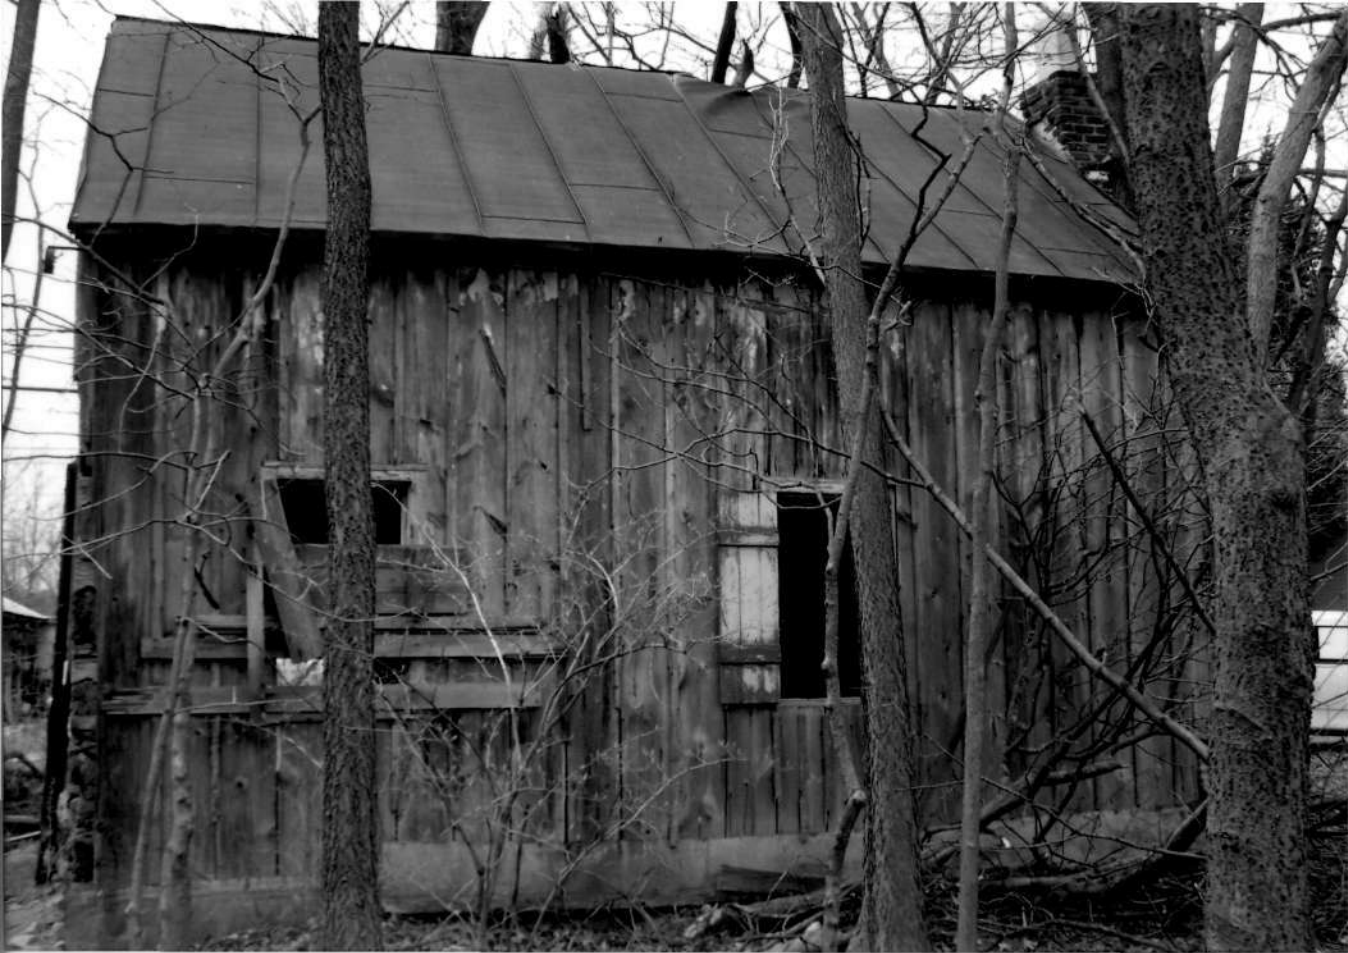
Log House, east elevation, facing west  
2 of 11

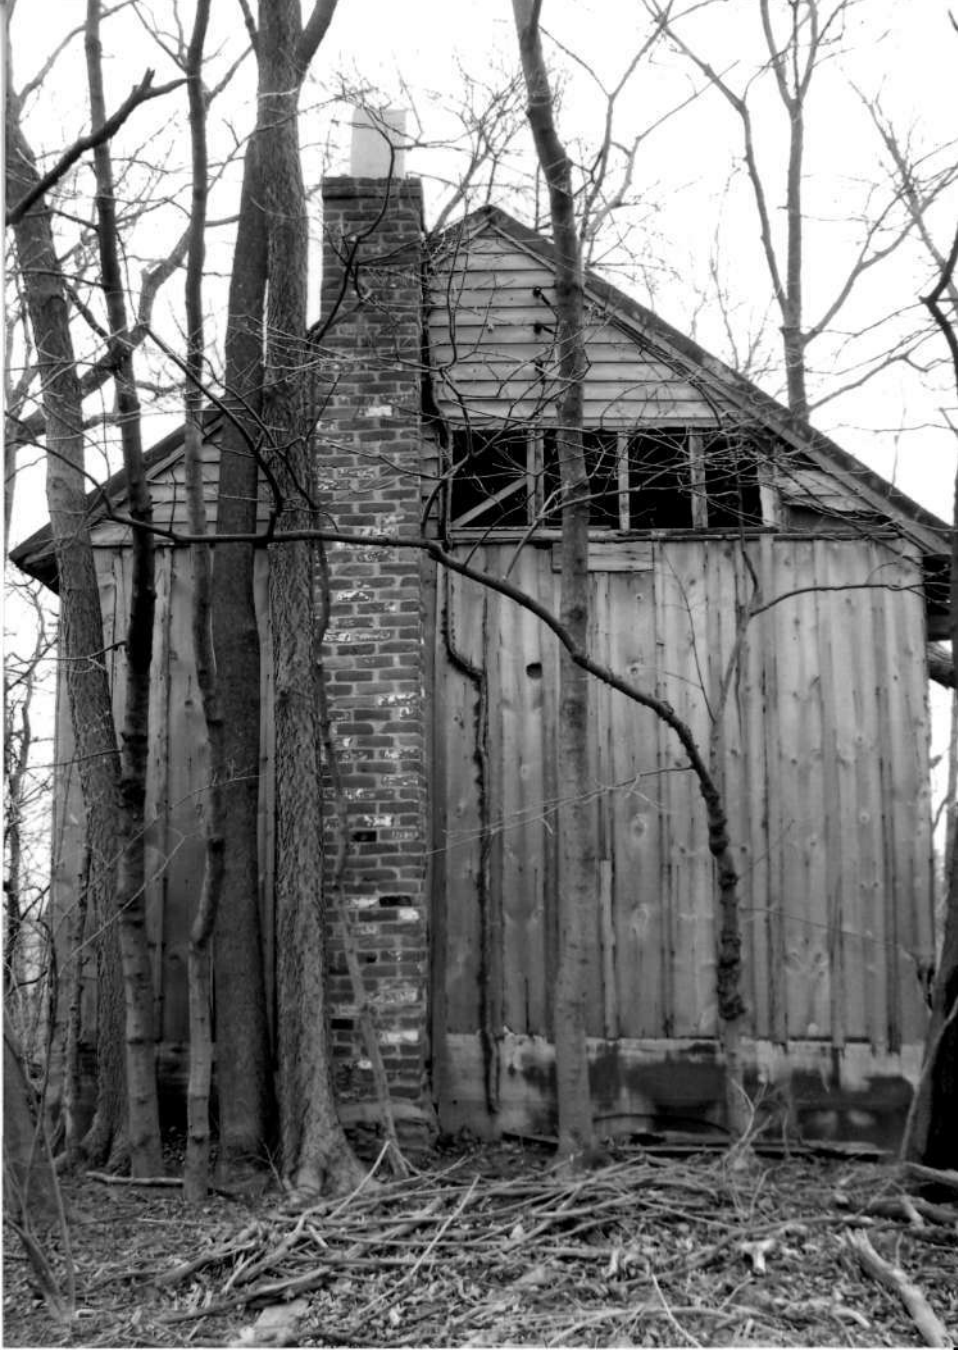
3 of 11

Log House, north elevation, facing south

Located on the north gable end is a narrow exterior brick chimney flue supported by a mortared stone foundation. Added probably during the late nineteenth or early twentieth century, the flue was used for an interior stove. The foundation on this side of the building as well as the east and west elevations is covered with sheet metal. In the gable, framing is exposed under the weatherboards. The exposed framing indicates the gable ends were not log, but stud framed. The wood used on this end exhibits circular saw marks suggesting a construction date of the mid-nineteenth century or later. A small window opening is also present in the gable; however, the sash is missing. This opening is mirrored on the south gable end.

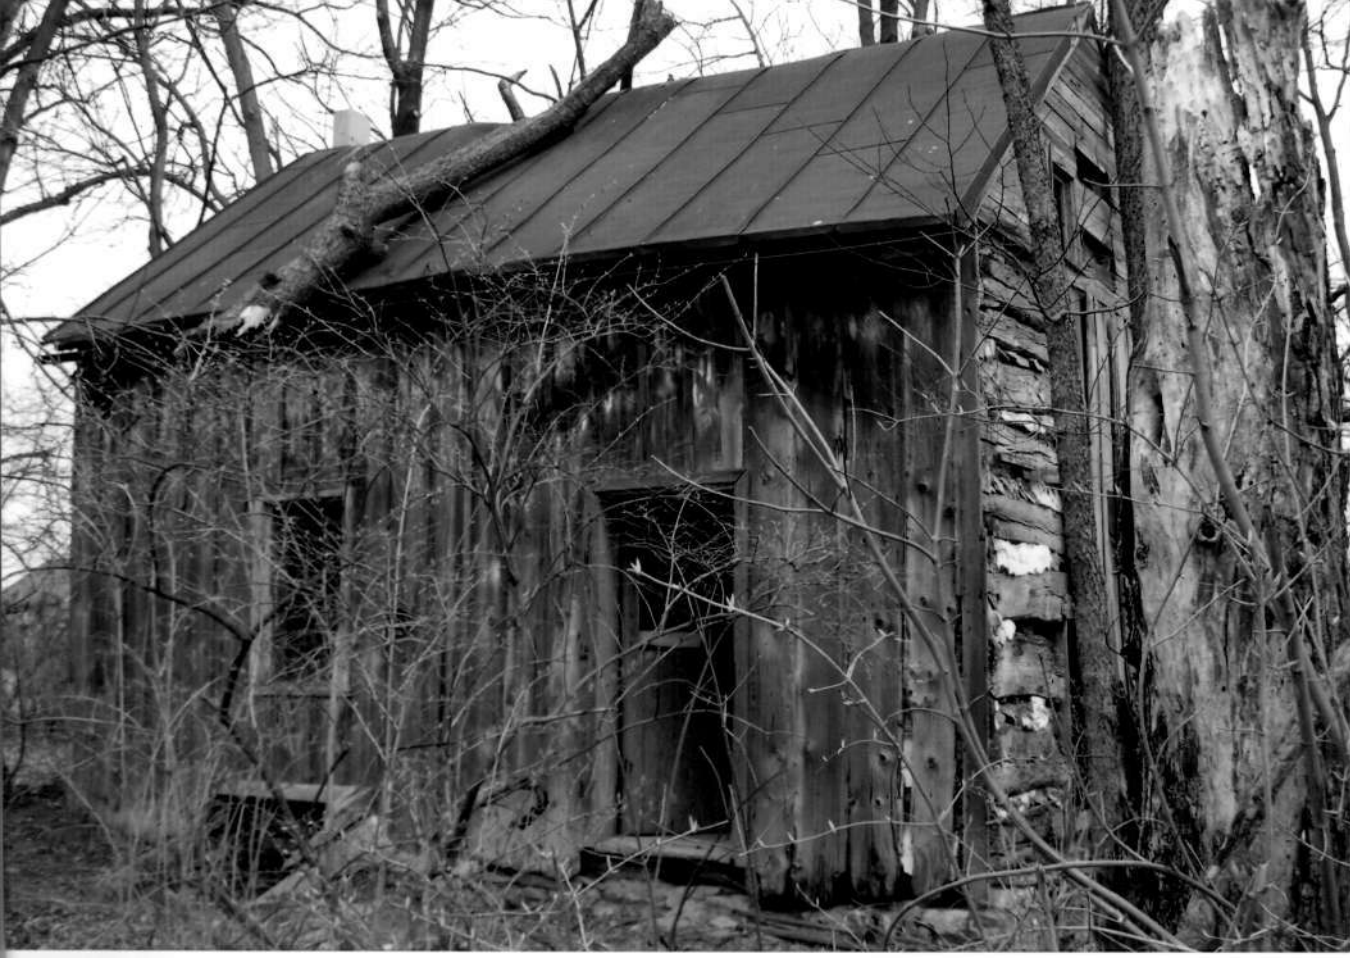
4 of 11

Log House, West elevation, facing southeast

The west façade features a single window in the first bay, directly over the bulkhead, and an entry door in the second bay. The window is missing; however the remnants left in the frame indicate a sash style window and the opening size suggests a six-over-six or two-over-two configuration. Shutter pins are extant on the window frame and a single wood shutter survives on the rear (east) elevation north window. The window frame exhibits numerous layers of paint, though most areas are void of paint due to exposure to the elements. Entry into the dwelling is by a board and batten style door and is the only entrance into the building. The interior of the door exhibits heavy paint layers. The latch, not the original, is a rim lock minus the door knob. The cut-out in the middle batten of the door indicates a larger or taller rim lock was originally in place. The door is hung with cast iron loose-joint butt hinges. Both the entry door and window have plain board surrounds; however, a bead is visible within the frame of the window suggesting the window surround may have been more ornate and was added onto to accommodate the depth of the opening after the board and batten sheathing was attached.

Access to the basement is through a bulkhead on this side of the house. The bulkhead walls are constructed of coursed fieldstone with subsequent layers of brick and mortar, possibly to raise the wall height to accommodate fill layers. The door to the bulkhead is missing and the steps into the basement are inaccessible; however, by looking into the basement from the present ground surface it is apparent that the basement is located only under two-thirds of the building. The floor boards over the remaining third, though appearing to have a full foundation according to the archaeological record, are only about a foot above the ground surface.

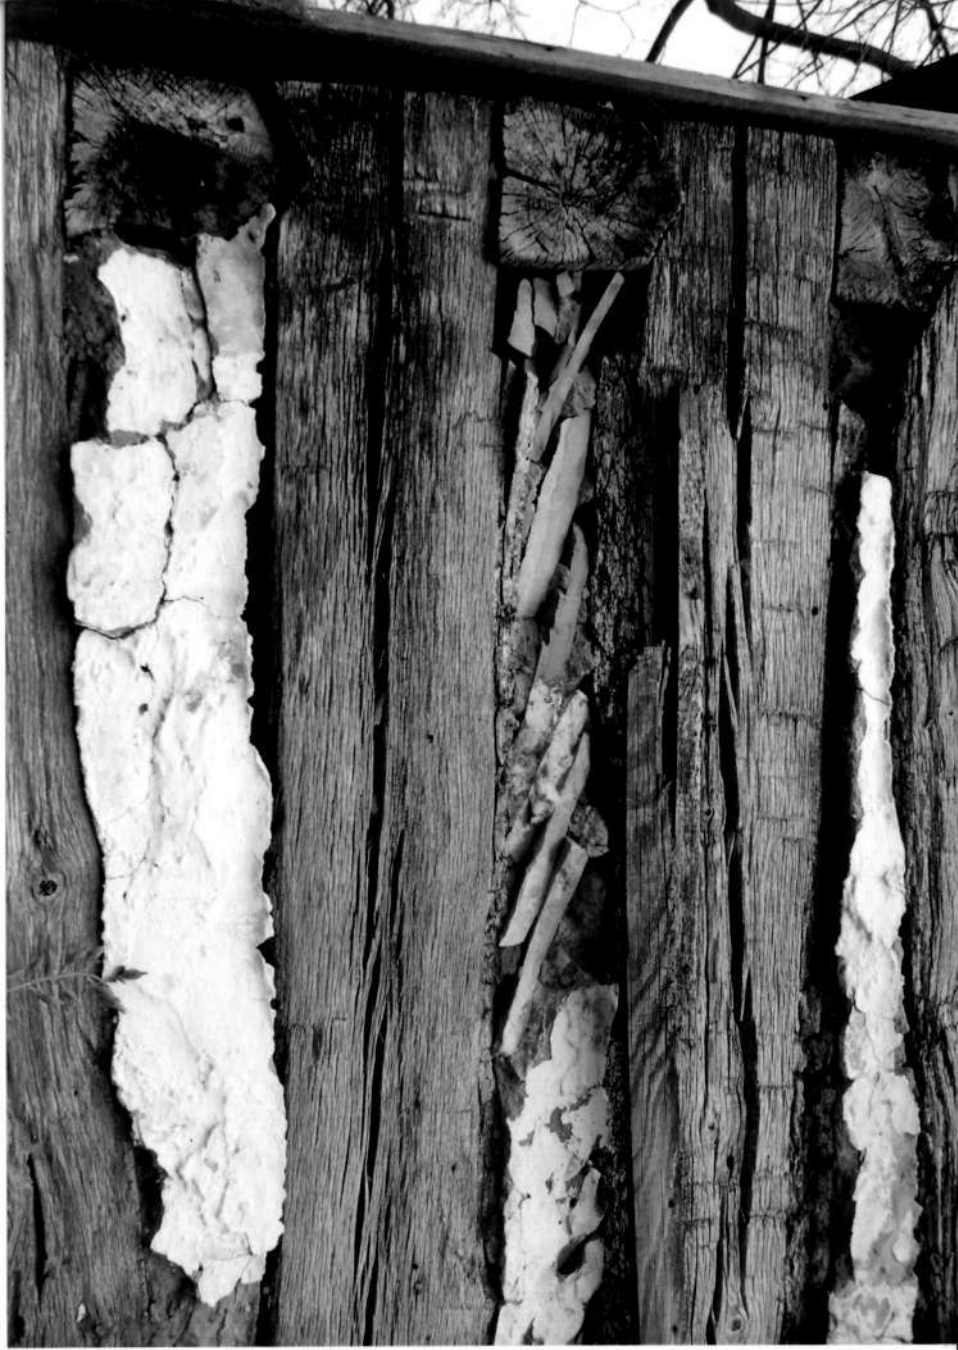
Log House, detail of log wall showing chinking,  
5 of 11 facing north

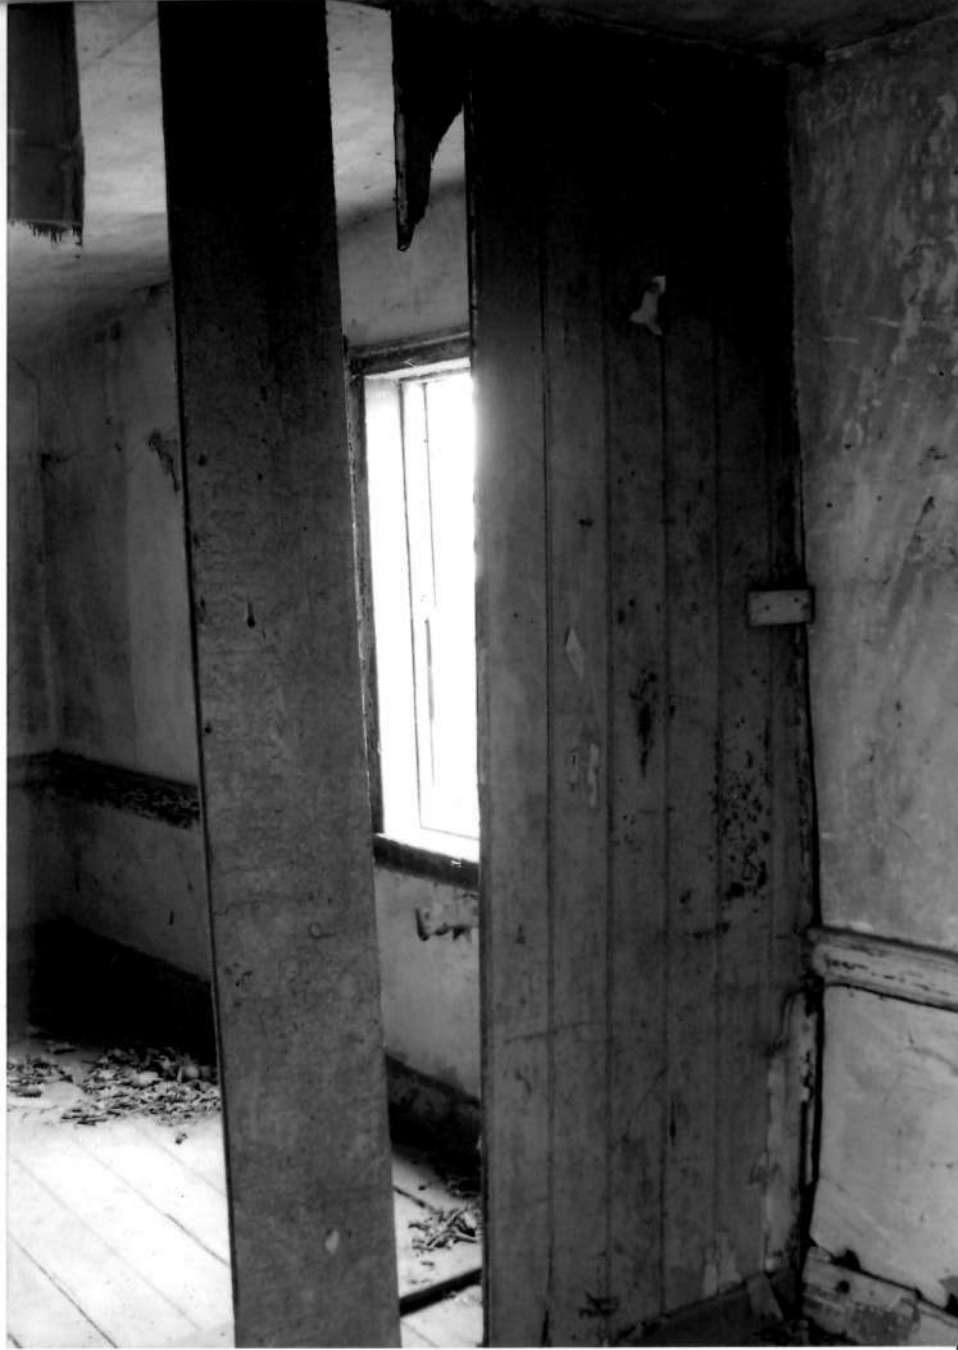
6 of 11

Log House, interior, division wall, facing northeast

The interior plan consists of two rooms on the first floor and two in the attic loft space. Each of the room division walls are constructed of tongue and groove boards with a bead on the tongue edge. The first floor wall is toe nailed with cut nails into a nailing board attached to the floor boards. A seam in the floor, which corresponds to the edge of the south foundation wall and to cut-outs in the chair rail, suggests the wall may have been moved approximately two feet to the north. The floor boards to the north of the seam show a substantial amount of wear consistent for the age of the building; however, the floor boards to the south are more modern and appear to be twentieth century. The reason for their replacement is unknown and speculative. This is the area of the house of the former kitchen area. Evidence of the fireplace on the interior is visible in the form a plaster line showing the former location of a mantle shelf. Lines in the plaster also provide visual evidence that the firebox has been filled in. After the firebox was filled-in, a stove pipe hole was cut into the exterior wall.

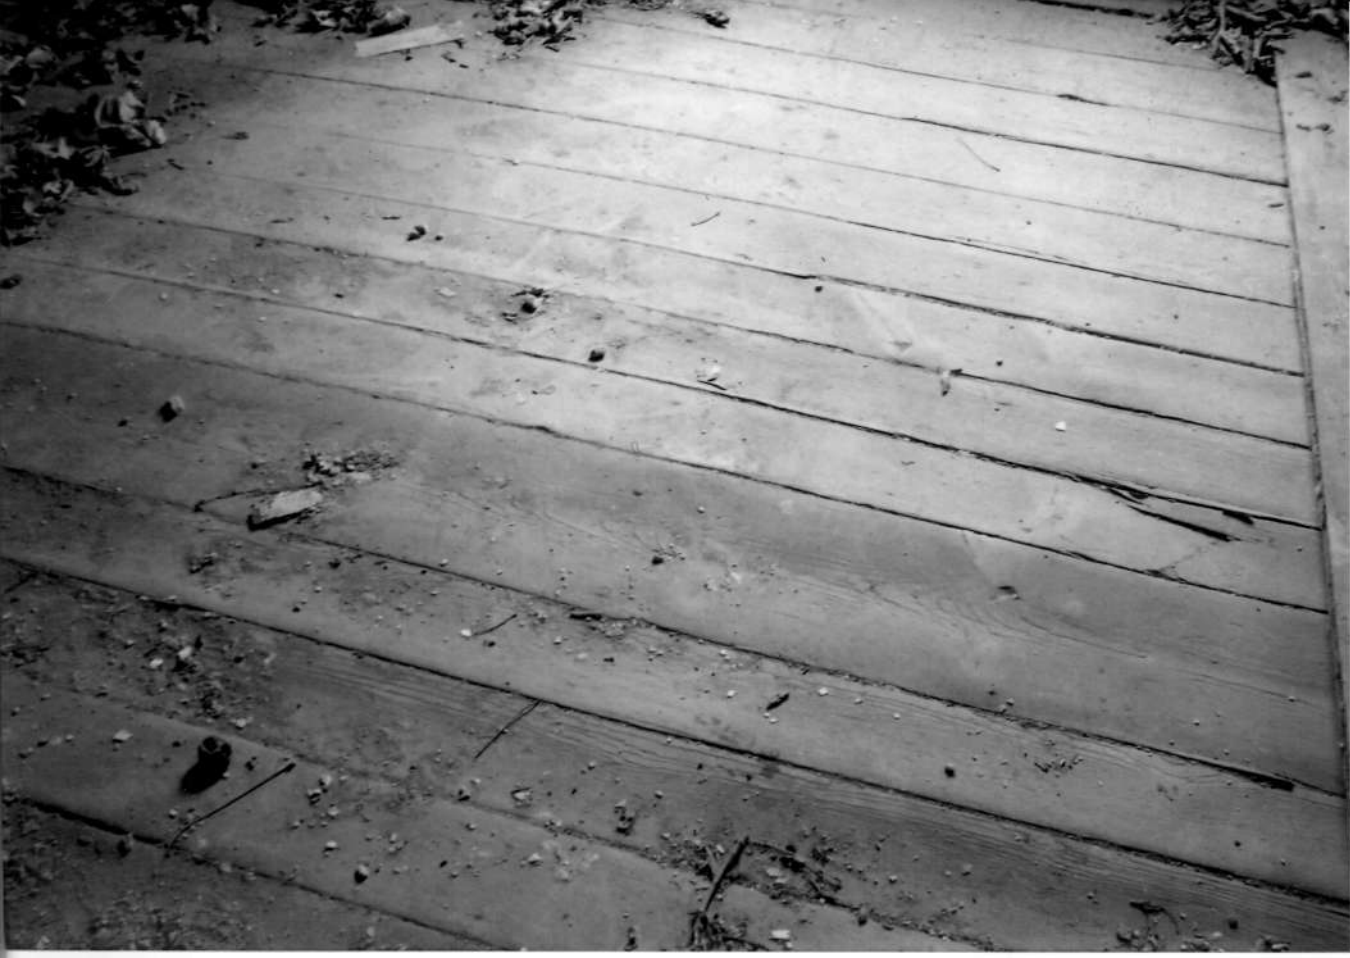
Log House, interior, floor, facing northeast

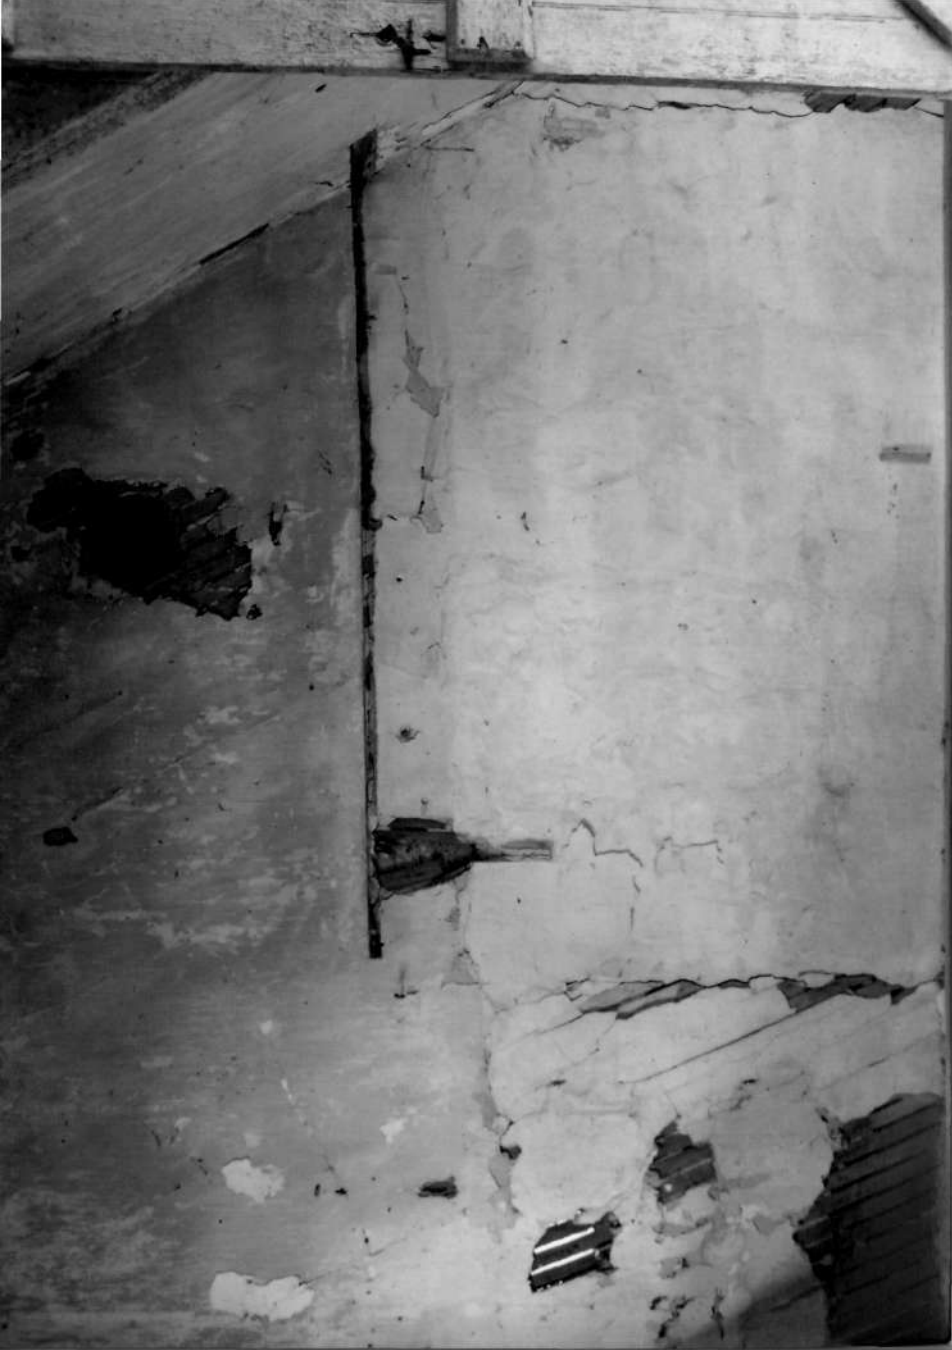
8 of 11

Log House, interior, south wall showing line of mantel shelf,  
facing south

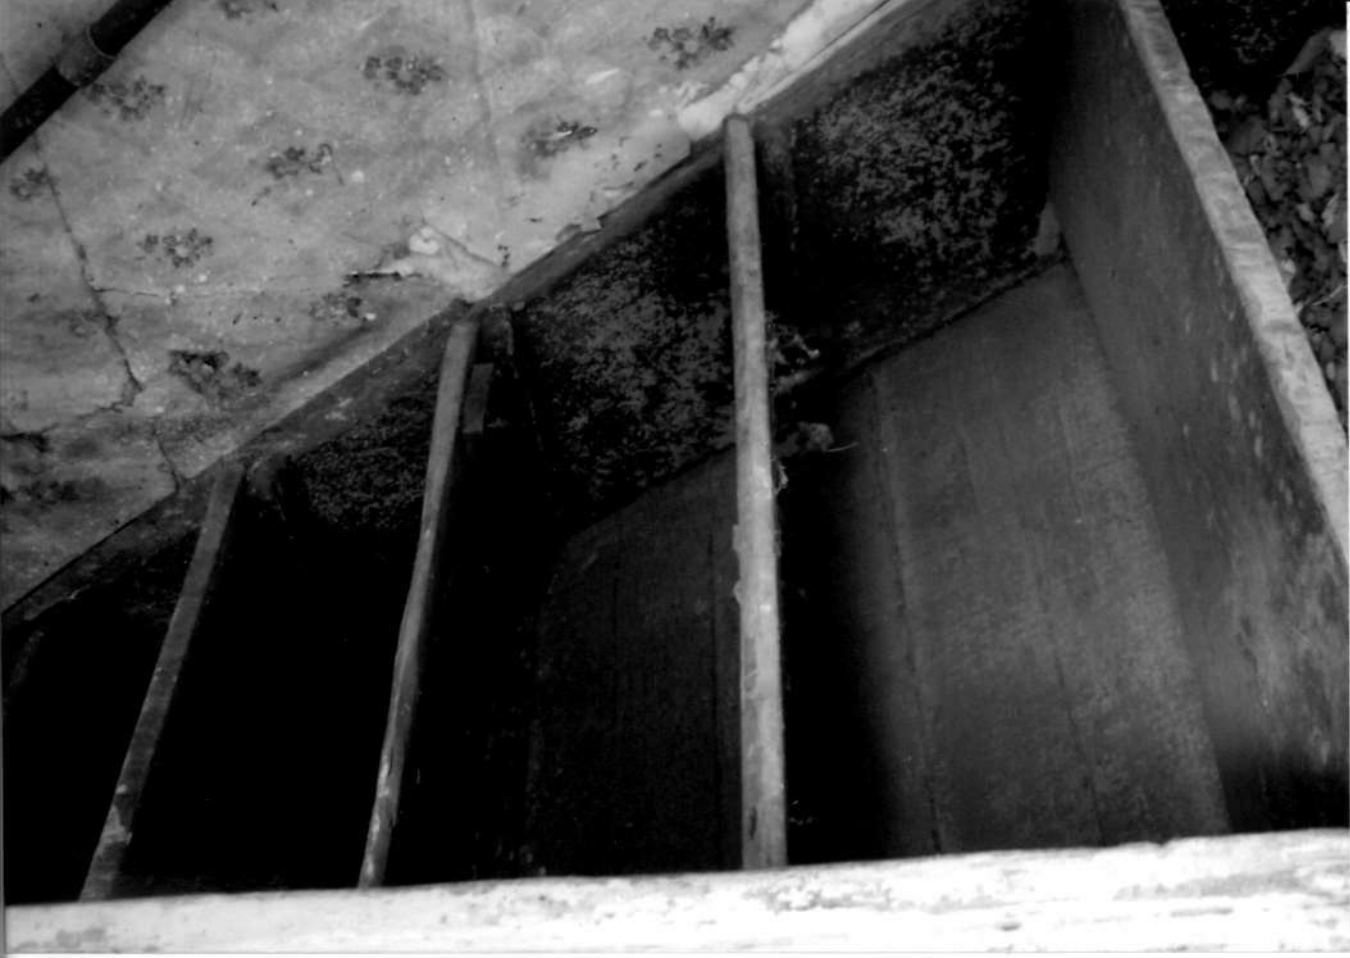
9 of 11

Log House, interior, stair detail, facing southeast

Along the south wall is an enclosed straight run staircase that provides access to the attic loft area. Most of the treads show substantial wear. The south wall of the stair is papered with a mid-twentieth century design as are the lower walls in the loft. The north wall of the stair is a board wall attached with cut nails. The door to the stair is board and batten similar to the front entry door; however the bottom edge has been diagonally cut to match the angle of the staircase. The attic is finished throughout and exhibits some change in interior finishes. Though the walls and ceiling of the space have been covered with wallboard, portions have dislodged exposing the roof framing. The framing consists of common rafters with collar ties. Shingle lath has been attached to the exterior side of the rafters and is used as nailing boards for the wood shingle roof. The shingles from the exterior are not visible as the present roof surface is seamed metal. Both the roof framing and the interior side of the shingles have been whitewashed and/or painted and exhibit a similar amount of layers as the ceiling framing on the first floor. The rafters are pegged with a ridge board attached to the exterior side. A full height board wall divides the space in half and has been painted. A door in the center of the wall with plain board surround provides access into the north room.

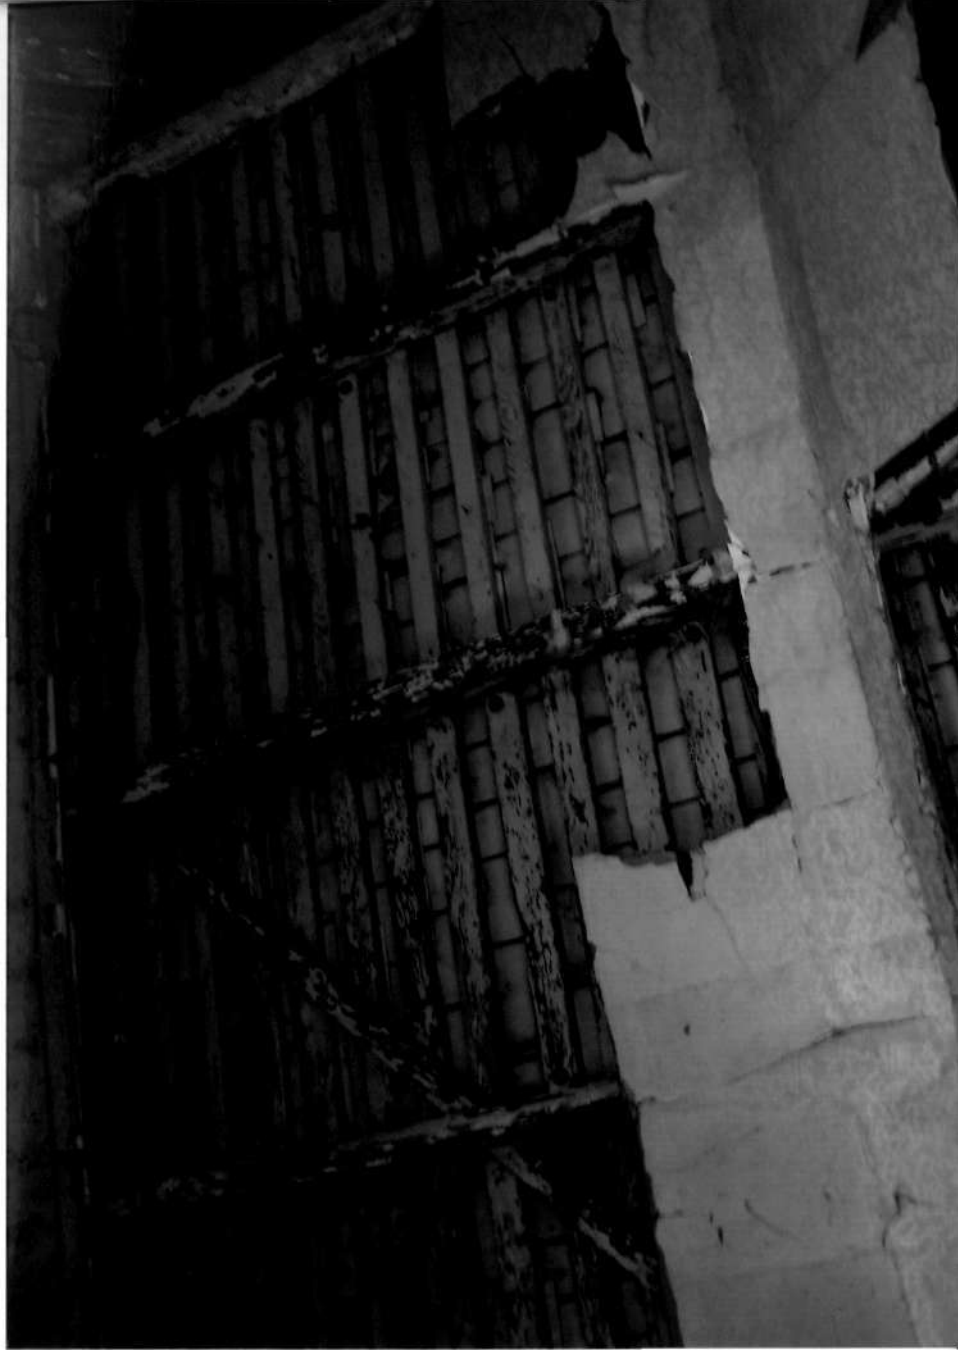
10 of 11

Log House, interior, roof framing, facing northeast
